Chip Errata for the i.MX28

This document details all known silicon errata for the i.MX28. [Table 1](#) provides a revision history for this document.

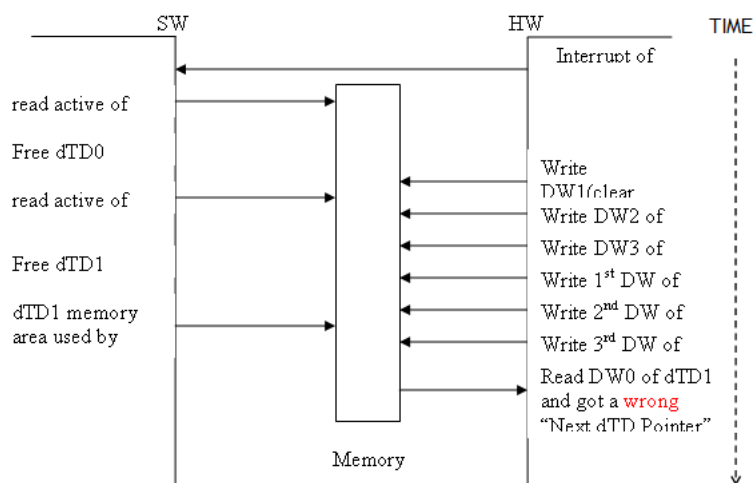
Figure 1. dTD Issue Sequence of Events

2858 USB controller may access a wrong address for the dTD (endpoint transfer descriptor) and then hangs

After step 1, if software finds the Active bit is cleared, then the dTD memory space is freed and may be allocated for another thread's use. In step 3, hardware may get a wrong dTD.

This issue only occurs in USB INCR8 mode, because steps 1 and 2 have 6 SINGLE AHB transfers in INC8 mode, but only two burst AHB transfers in INCR mode.

This issue only occurs when the dTD list is used; because if only one dTD is used, the software only checks the Active bit after an interrupt is received (step 3). However, when the dTD list is used, the software may check the entire list after the interrupt for the first dTD is received, when the hardware has just finished the transfer of the second dTD.

USB Controller may hang if dTD is freed too quickly.

Postpone freeing the current dTD; free it when its next dTD can be freed, so the last completed dTD (followed by an ACTIVE dTD) is always freed when the next IOC irq comes.
