# PIC18F2525/2620/4525/4620

## PIC18F2525/2620/4525/4620 Rev. A3 Silicon Errata

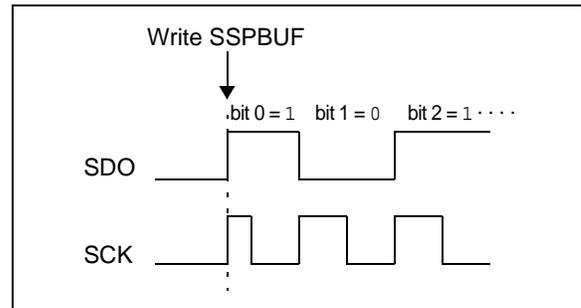
**FIGURE 1: SCK PULSE VARIATION USING TIMER2/2**

When the SPI is using Timer2/2 as the clock source, a shorter than expected SCK pulse may occur on the first bit of the transmitted/received data (Figure 1).

To avoid producing the short pulse, turn off Timer2 and clear the TMR2 register, load the SSPBUF with the data to transmit and then turn Timer2 back on. Refer to Example 5 for sample code.
